Home Inspection Report

4118 Eastham Rd

Virginia Beach, VA 23453

Inspected on Mon, Mar 18 2019 at 10:46 AM

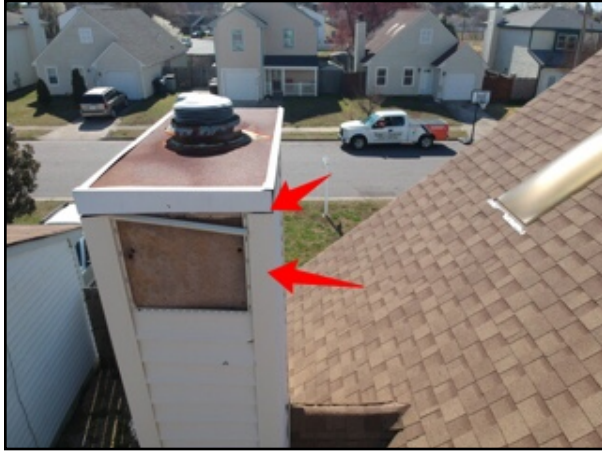
Figure 1-1

Siding missing at chimney. Repair is recommended by a qualified vinyl siding contractor.

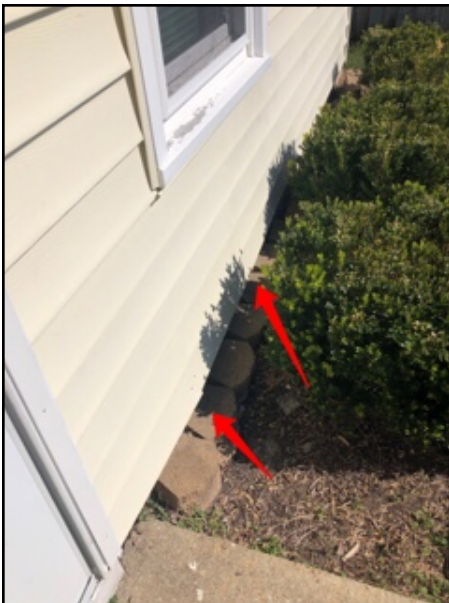
Figure 3-1

Loose vinyl siding, bottom row, front & back of house, repair is recommended by a qualified vinyl siding contractor.

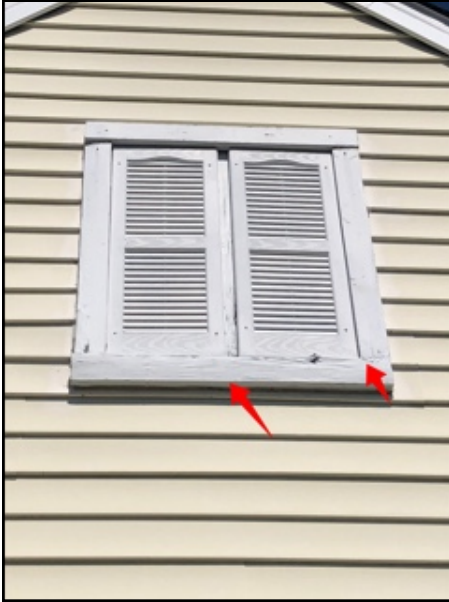
Figure 4-1

Damaged wood trim at front of house, gable vent. Repair is recommended by a qualified handyman

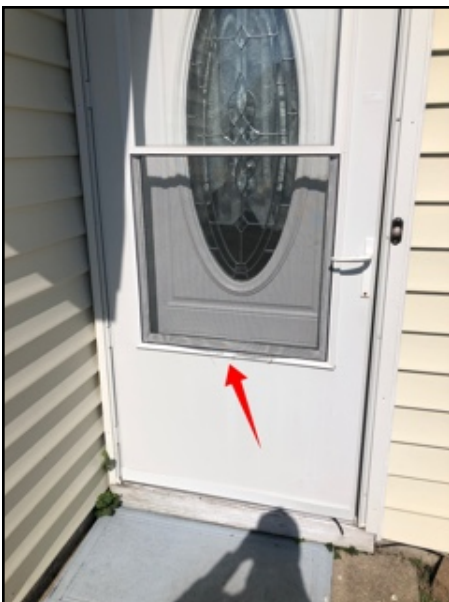
Figure 5-1

Damaged screen at front door. Replacement is recommended by a qualified handyman.

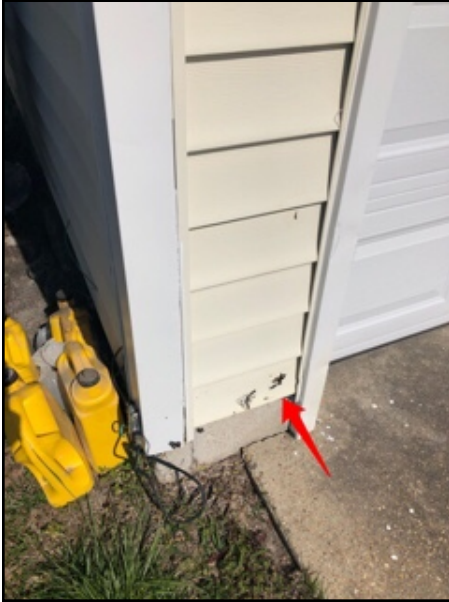
Figure 6-1

Damaged vinyl siding at left side of garage door, replacement is recommended by a qualified vinyl siding contractor.

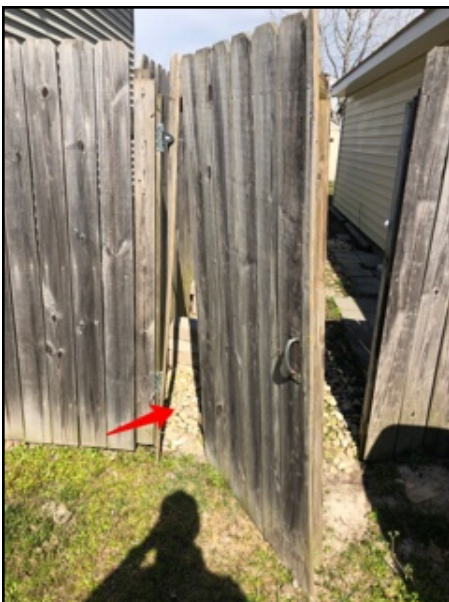
Figure 7-1

Damage to gate at left side of house. Repair is recommended that a qualified handyman.

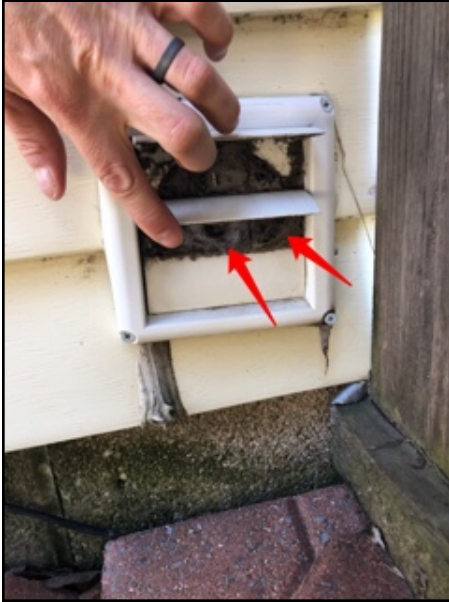
Figure 8-1

**Comment 8:**
Dryer vent clogged, cleaning and vacuuming is recommended by a qualified handyman.

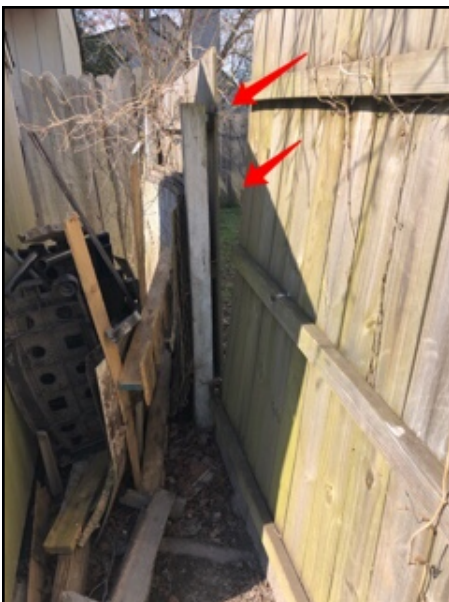
Figure 9-1

**Comment 9:**
Loose fence panels at back of property, repair is recommended by a qualified handyman.

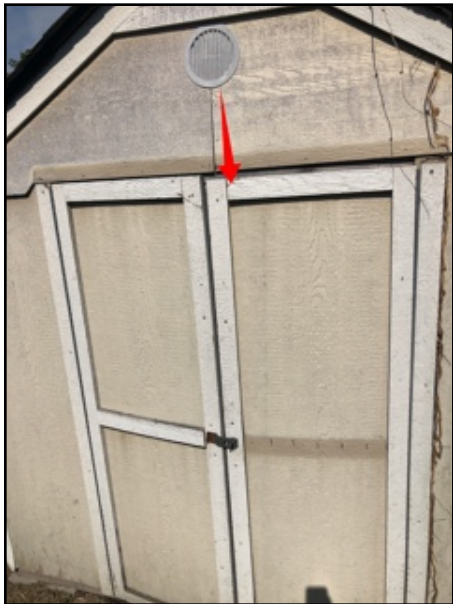
Figure 11-1

**Comment 11:**
Shed doors do not shut properly here. Repair is recommended by a qualified handyman.

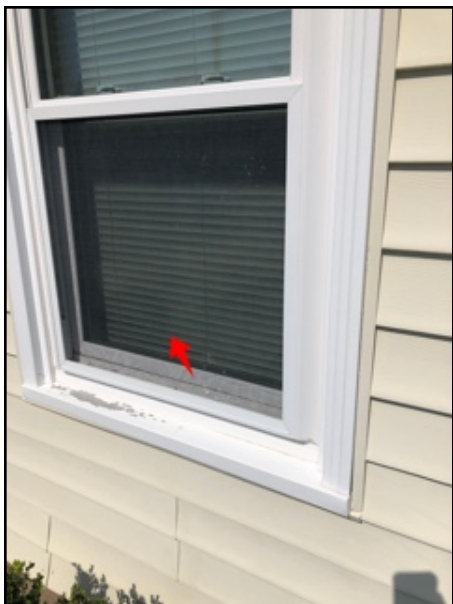
Figure 12-1

**Comment 12:**
Damaged window screens at front & back of house, repair is recommended by a qualified handyman.

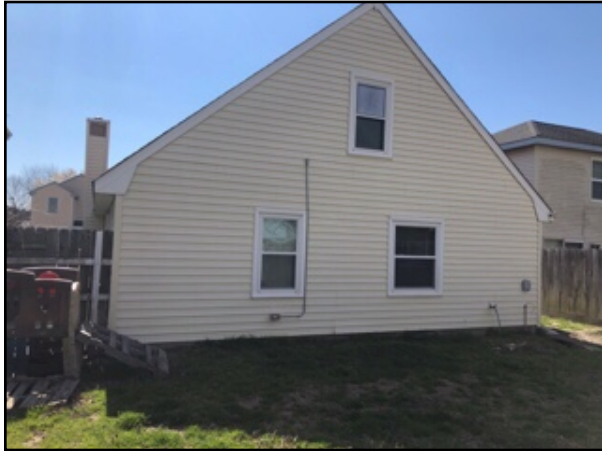
Figure 13-1

**Comment 13:**
Gutters not installed on house, installation of gutters at left and right side is recommended by a qualified gutter installer.

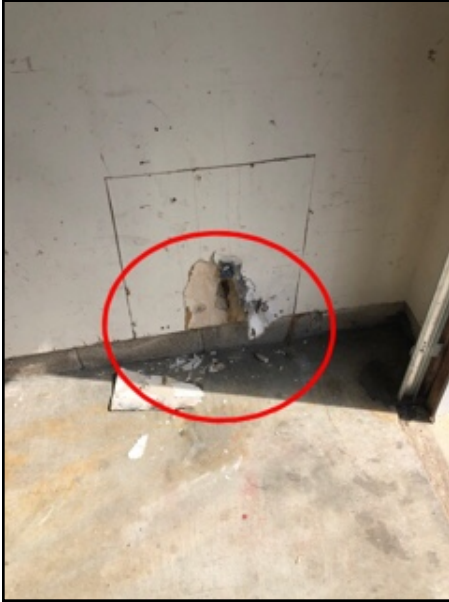
Figure 15-1

Damage drywall at garage, repair/replacement is recommended by a qualified drywall contractor.

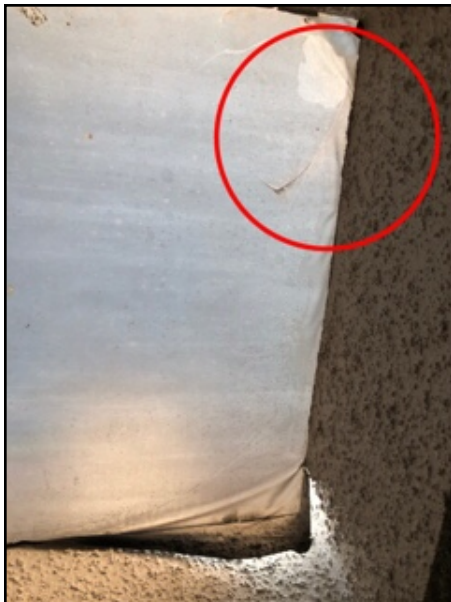
Figure 17-1

Plastic lens covering skylight is cracked, loft skylight. Replacement is recommended by a qualified roofing contractor.

Small crack in skylight, middle of room of living room. Repair is recommended by a qualified roofing contractor.

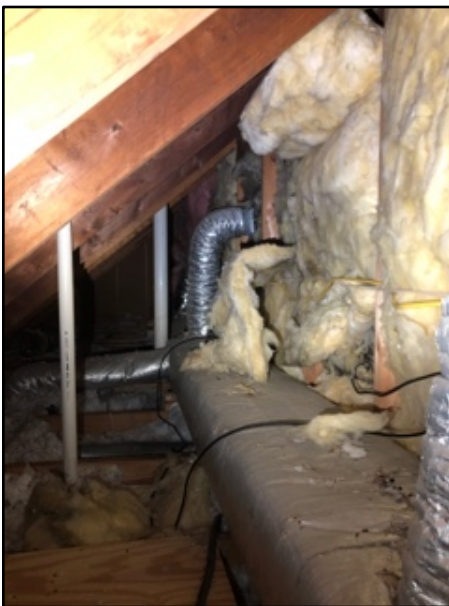
Figure 18-1

Missing insulation at interior walls facing attic. Replacement of missing insulation is recommended by a qualified insulation contractor.

Pest feces at attic. Pest treatment is recommended by a qualified termite and pest contractor.

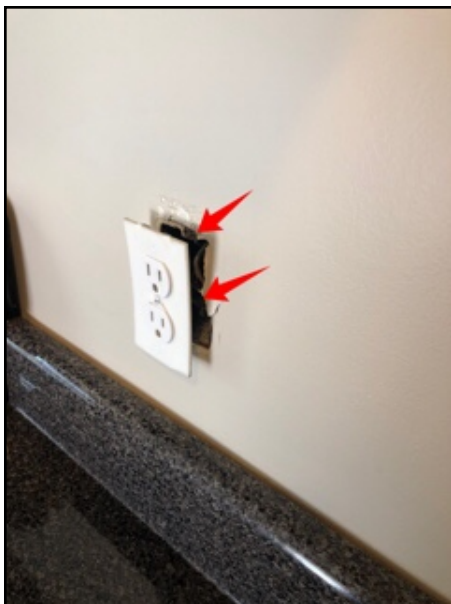
Figure 20-1

Outlet loose at kitchen, repair is recommended by a qualified electrician.

Kitchen outlets are not GFCI protected at sink. All outlets within 6 feet of any plumbing fixture must be GFCI protected. Installation of GFCI outlets or circuit is recommended by a licensed electrician.

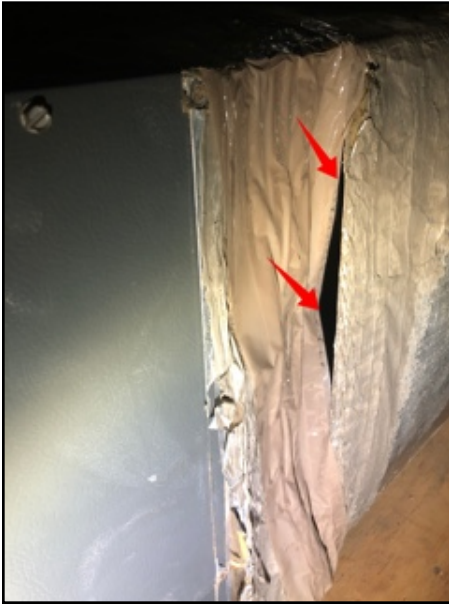
Figure 23-1

Return air duct loose at connection to cabinet, air coming in directly from attic. Correction and repair is recommended by a qualified HVAC contractor.

Check valve not connected at air handler in attic. Further evaluation is recommended by a qualified HVAC contractor.

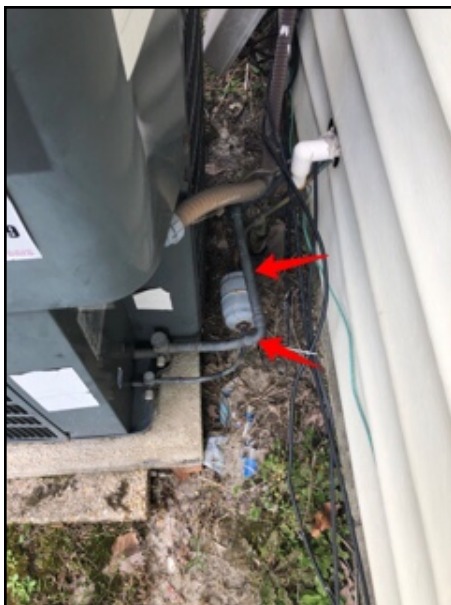
Figure 25-1

Damaged insulation at refrigerant lines. Repair and replacement is recommended by a licensed handyman for HVAC technician.

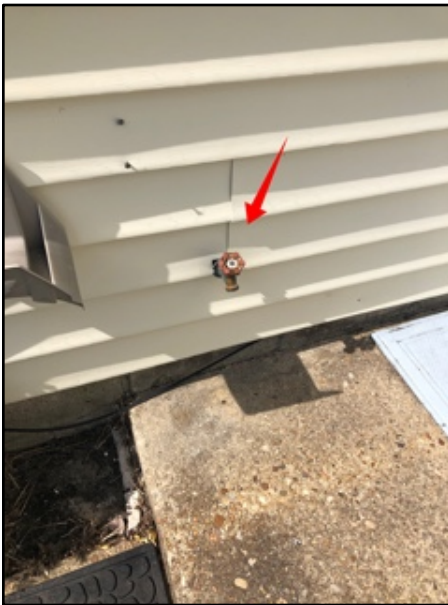
Figure 26-1

Spigot loose at front of house, repair is recommended by a qualified plumbing contractor.

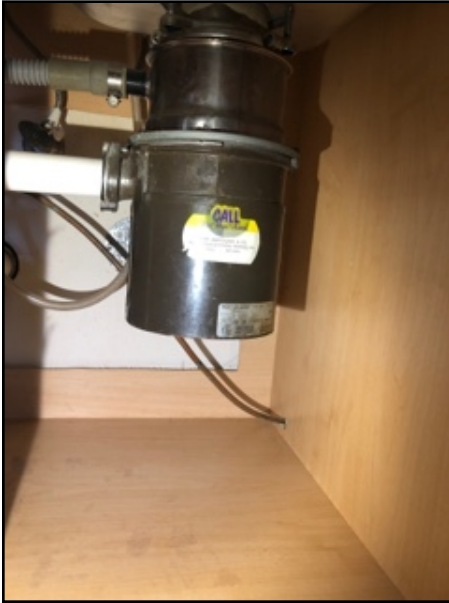
Figure 28-1

Disposal frozen, not working. Replacement is recommended that qualified plumber.

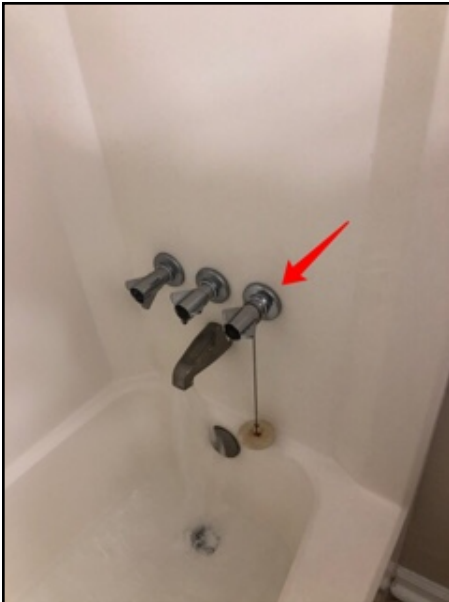
Figure 29-1

Hot and cold water handle this reversed/backwards Handle at right side is loose, screw is missing. Repair and correction is recommended by qualified plumber.

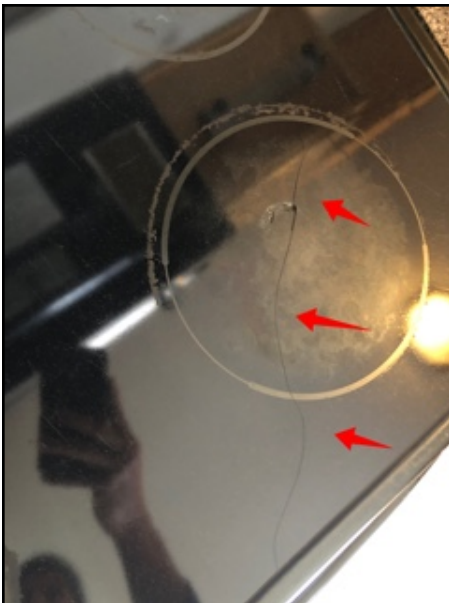
Figure 35-1

Cooktop crack at the top of range, replacement is recommended by a qualified appliance repair contractor.

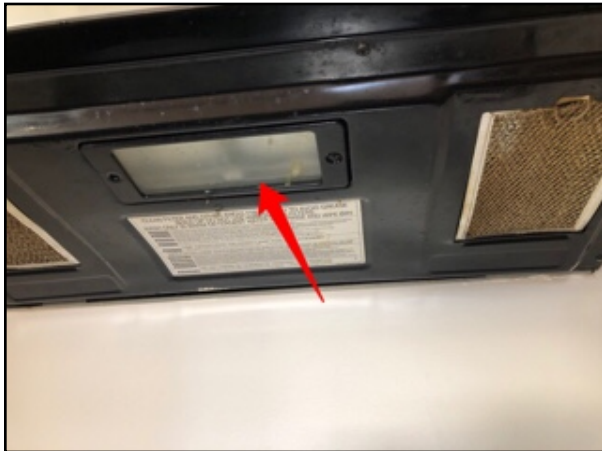
Figure 36-1

Lightbulb out at surface light, microwave. Replacement is recommended by a qualified handyman.

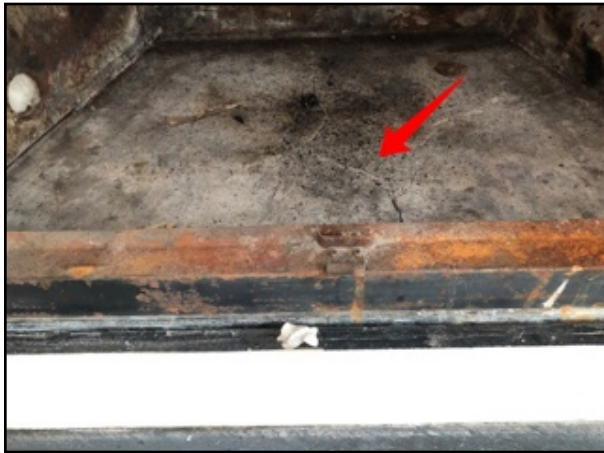
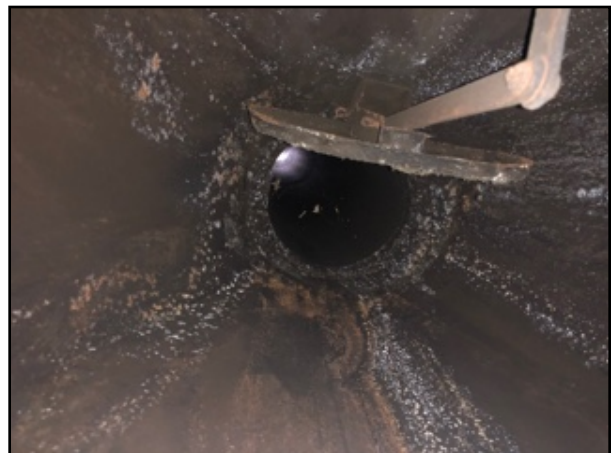
**Comment 38:**
Cracks in floor of firebox, rusty frame around firebox. Further evaluation is recommended by a qualified chimney sweep contractor.

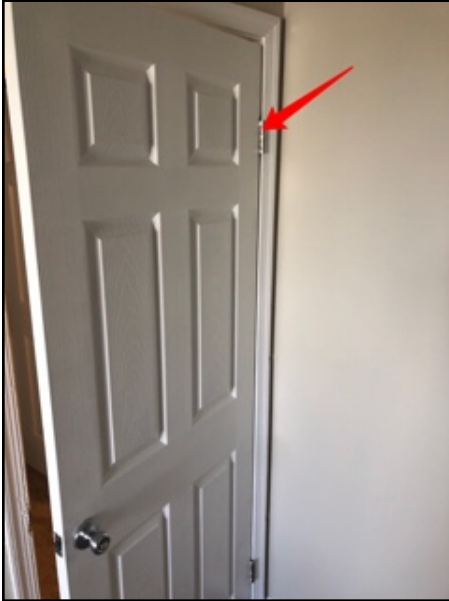
Figure 39-1

**Comment 39:**
Hinge loose at top of door, repair is recommended by a qualified handyman.

Master bedroom door.

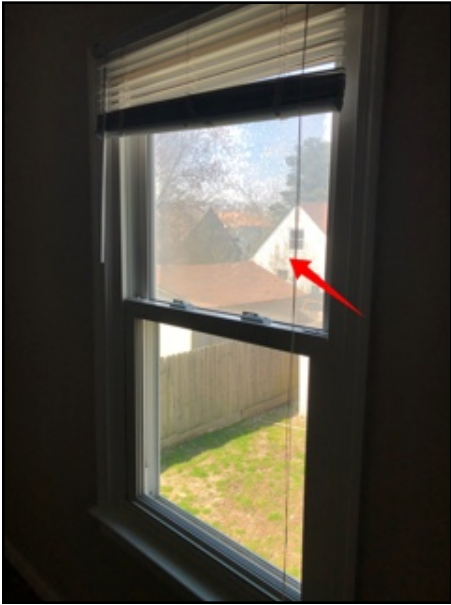
Figure 40-1

**Comment 40:**
Damaged glass at bedroom window, window is fogged. Repair is recommended by a qualified window replacement contractor.

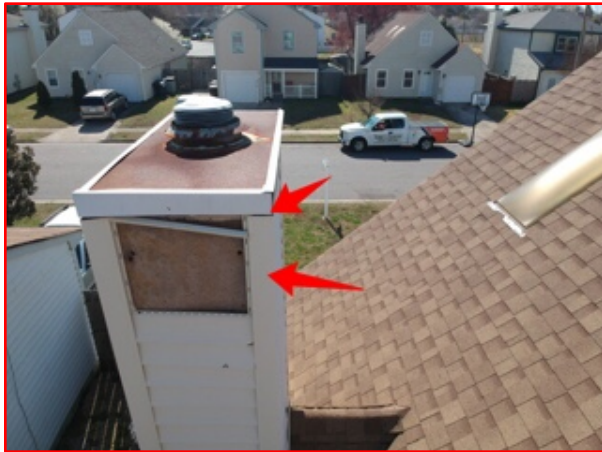
Figure 1-1

1) Siding missing at chimney. Repair is recommended by a qualified vinyl siding contractor.

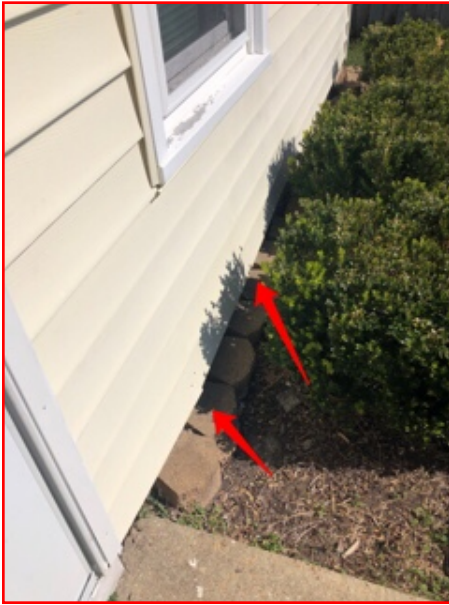
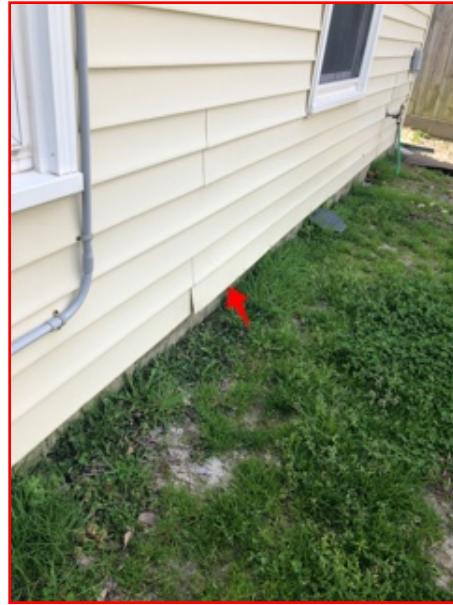
2) Loose vinyl siding, bottom row, front & back of house, repair is recommended by a qualified vinyl siding contractor.

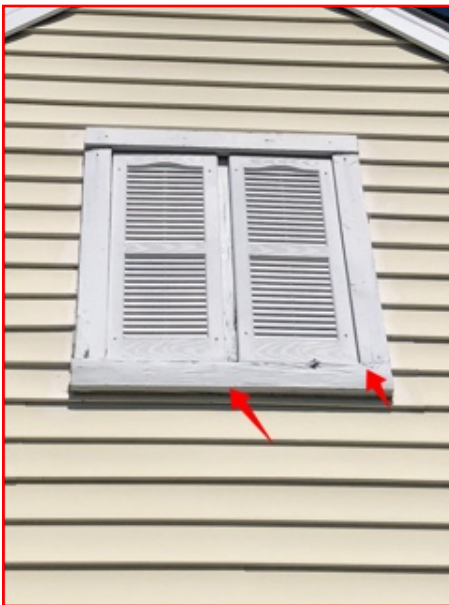
Figure 4-1

3) Damaged wood trim at front of house, gable vent. Repair is recommended by a qualified handyman

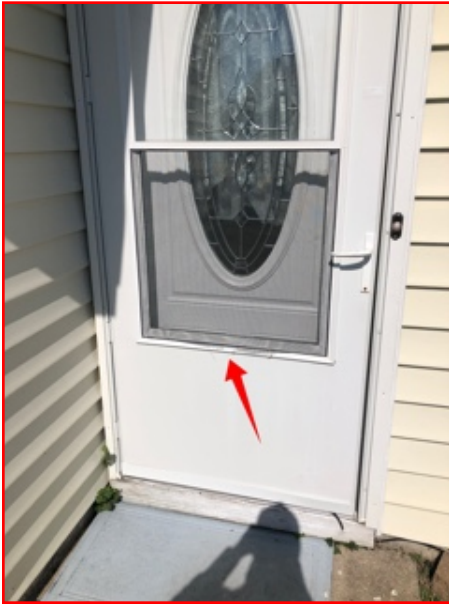
Figure 5-1

4) Damaged screen at front door. Replacement is recommended by a qualified handyman.

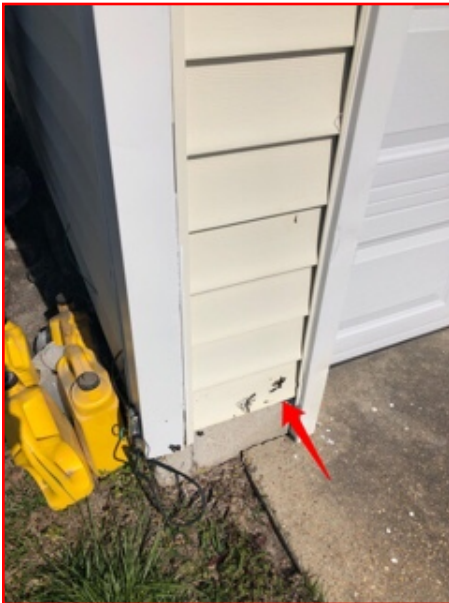
Figure 6-1

5) Damaged vinyl siding at left side of garage door, replacement is recommended by a qualified vinyl siding contractor.

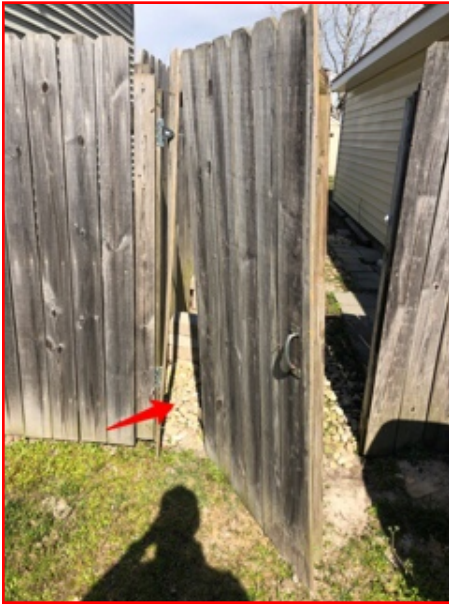
Figure 7-1

6) Damage to gate at left side of house. Repair is recommended that a qualified handyman.

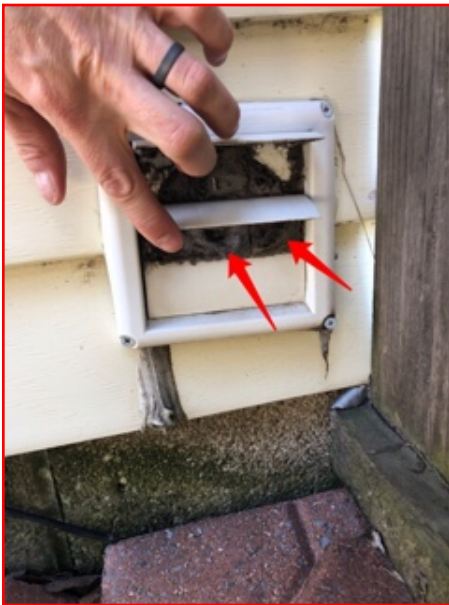
Figure 8-1

7) Dryer vent clogged, cleaning and vacuuming is recommended by a qualified handyman.

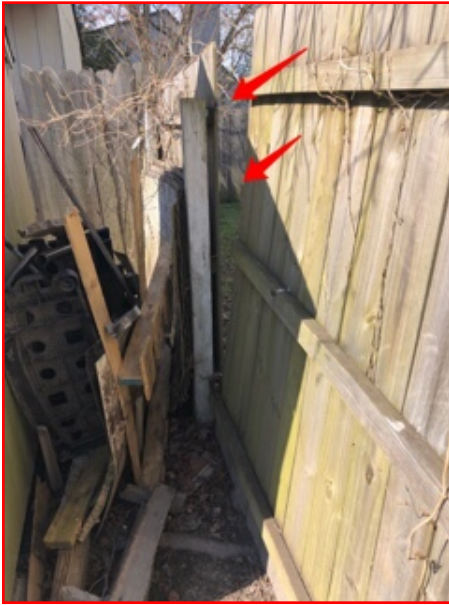
Figure 9-1

8) Loose fence panels at back of property, repair is recommended by a qualified handyman.

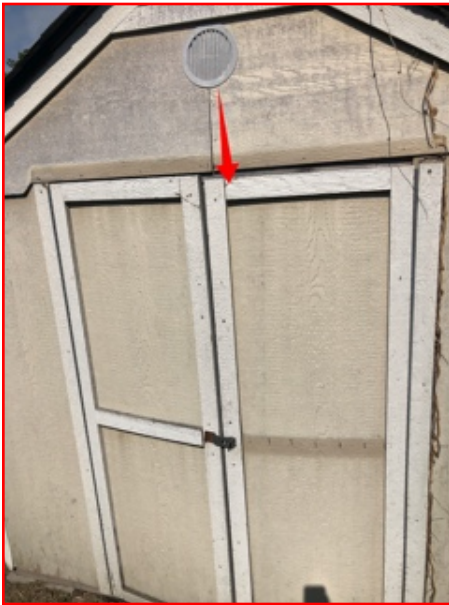
Figure 11-1

9) Shed doors do not shut properly here. Repair is recommended by a qualified handyman.

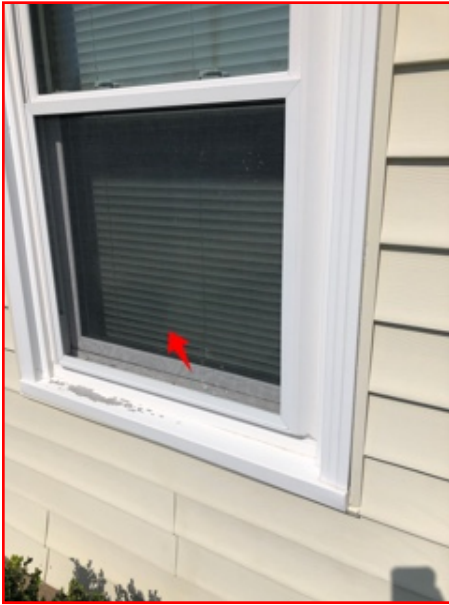
Figure 12-1

10) Damaged window screens at front & back of house, repair is recommended by a qualified handyman.

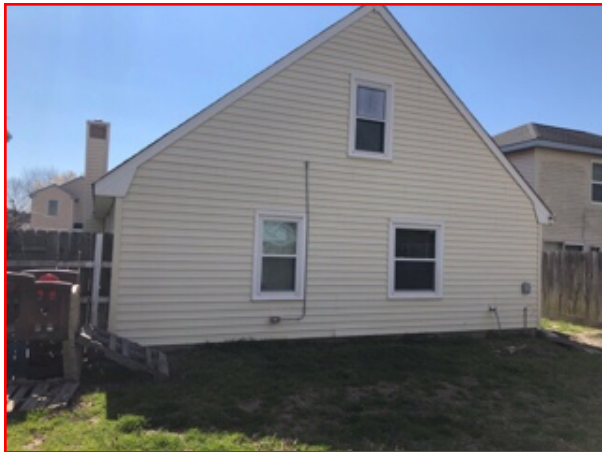
Figure 13-1

11) Gutters not installed on house, installation of gutters at left and right side is recommended by a qualified gutter installer.

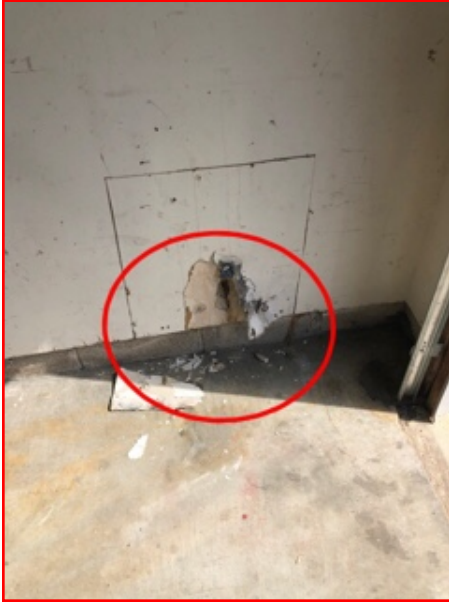
Figure 15-1

12) Damage drywall at garage, repair/replacement is recommended by a qualified drywall contractor.

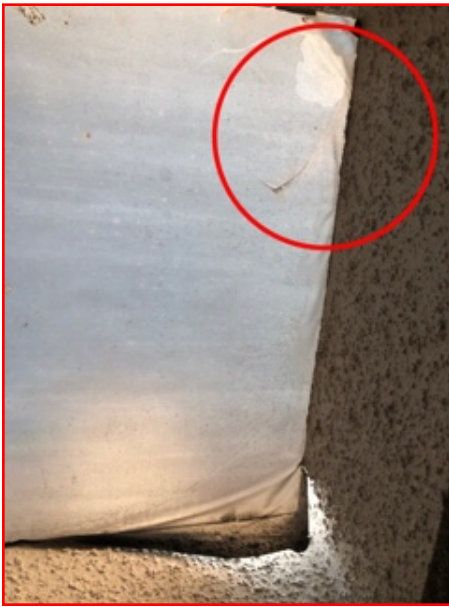
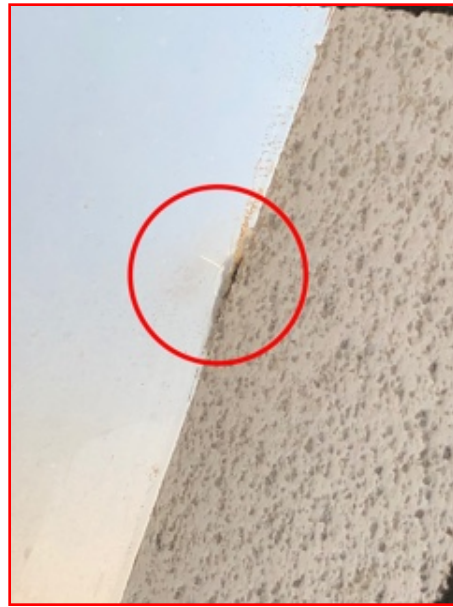
13) Plastic lens covering skylight is cracked, loft skylight. Replacement is recommended by a qualified roofing contractor.

Small crack in skylight, middle of room of living room. Repair is recommended by a qualified roofing contractor.

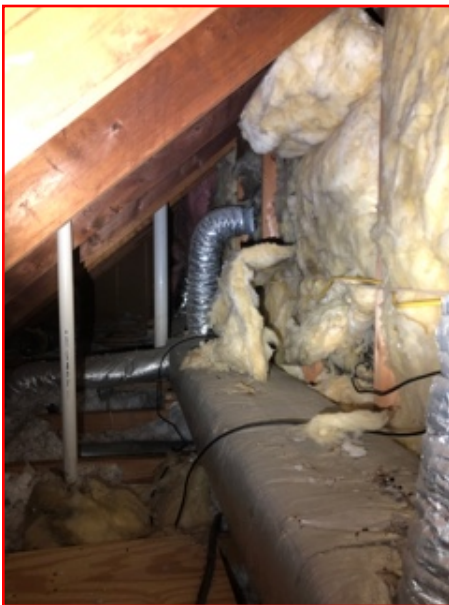
Figure 18-1

14) Missing insulation at interior walls facing attic. Replacement of missing insulation is recommended by a qualified insulation contractor.

Pest feces at attic. Pest treatment is recommended by a qualified termite and pest contractor.

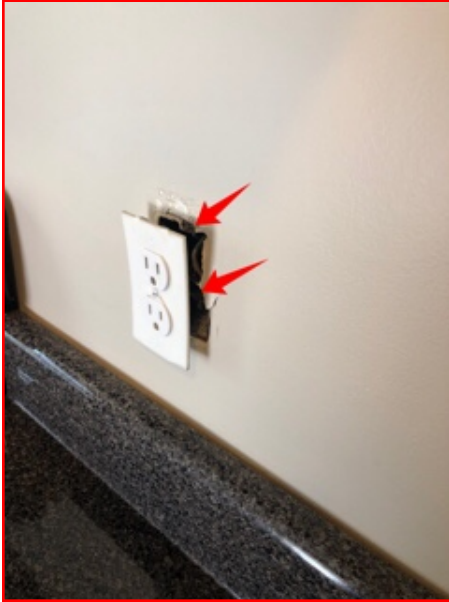
Figure 20-1

15) Outlet loose at kitchen, repair is recommended by a qualified electrician.

Kitchen outlets are not GFCI protected at sink. All outlets within 6 feet of any plumbing fixture must be GFCI protected. Installation of GFCI outlets or circuit is recommended by a licensed electrician.

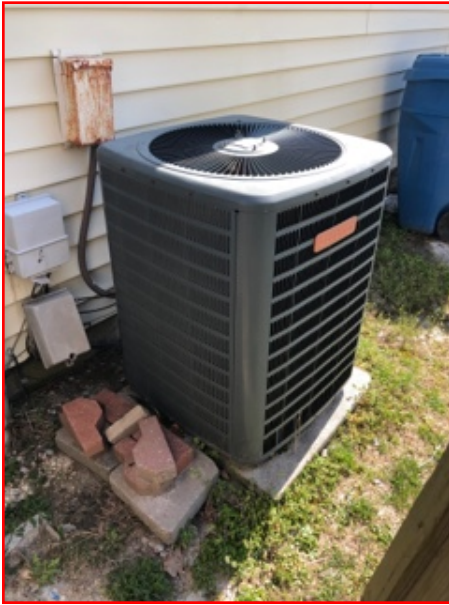
Figure 21-1

16) Heat pump manufactured in 2006. All equipment should be evaluated and cleaned by qualified HVAC technician.

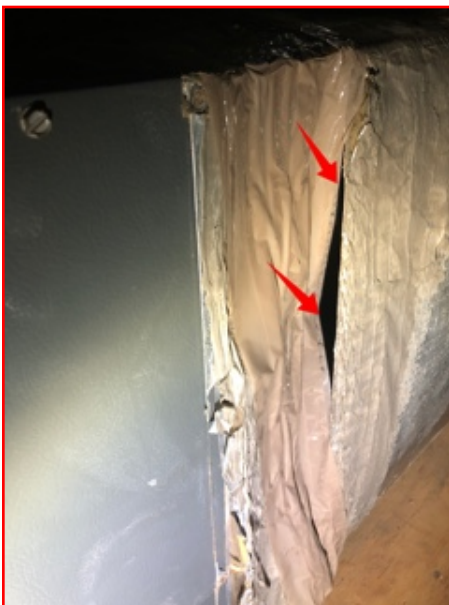
Figure 23-1

17) Return air duct loose at connection to cabinet, air coming in directly from attic. Correction and repair is recommended by a qualified HVAC contractor.

Check valve not connected at air handler in attic. Further evaluation is recommended by a qualified HVAC contractor.

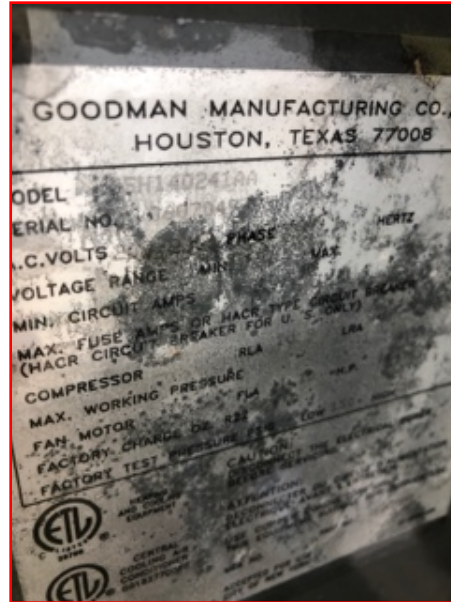
Figure 24-2

18) Heat pump manufactured in 2006. All equipment over 10 years old should be serviced and evaluated by a qualified HVAC technician.

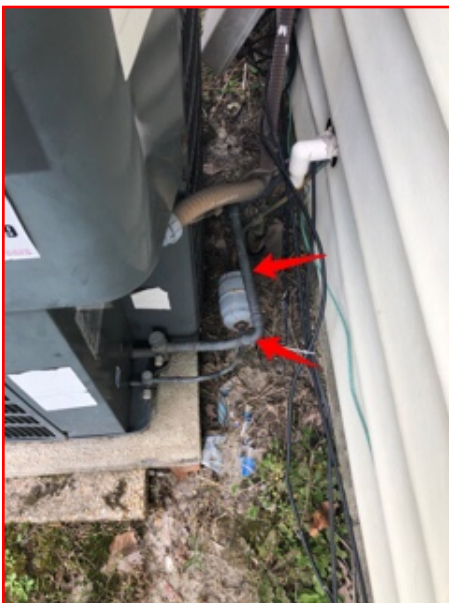
Figure 25-1

19) Damaged insulation at refrigerant lines. Repair and replacement is recommended by a licensed handyman for HVAC technician.

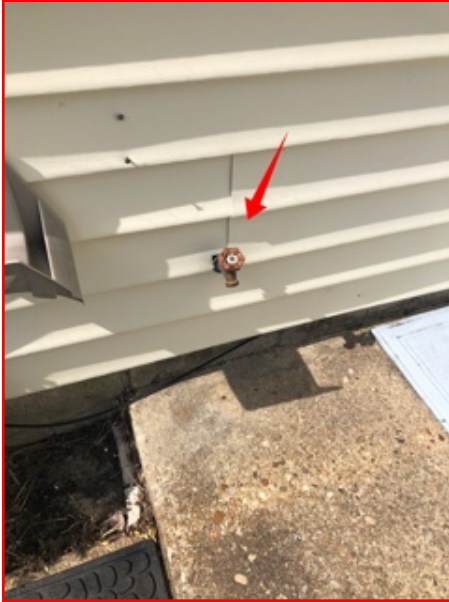
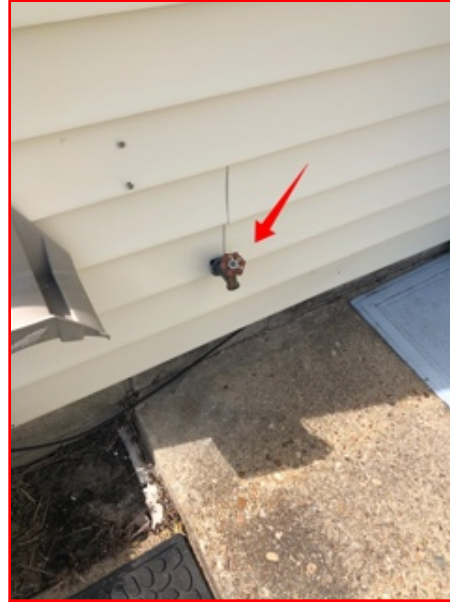
20) Spigot loose at front of house, repair is recommended by a qualified plumbing contractor.

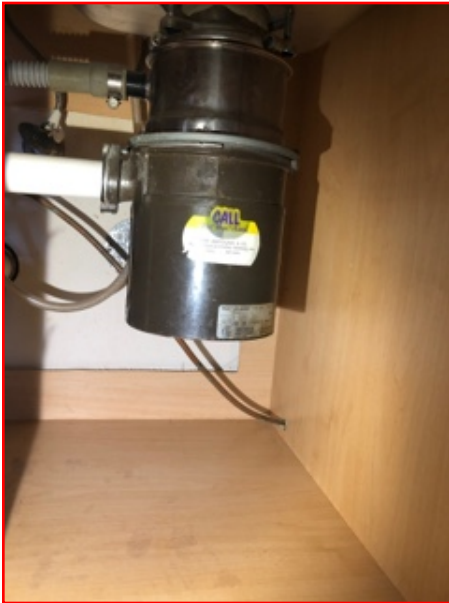
Figure 28-1

21) Disposal frozen, not working. Replacement is recommended that qualified plumber.

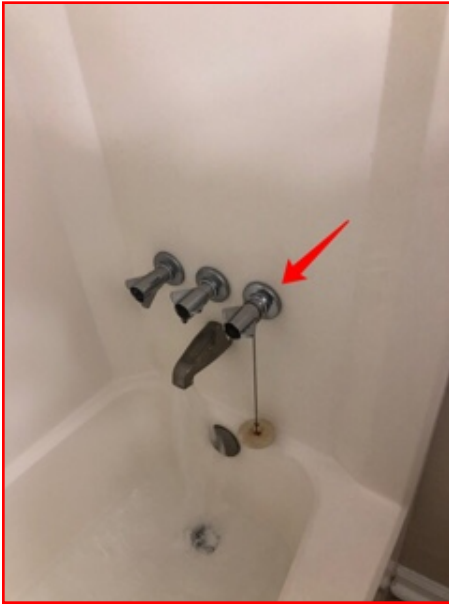
Figure 29-1

22) Hot and cold water handle this reversed/backwards Handle at right side is loose, screw is missing. Repair and correction is recommended by qualified plumber.

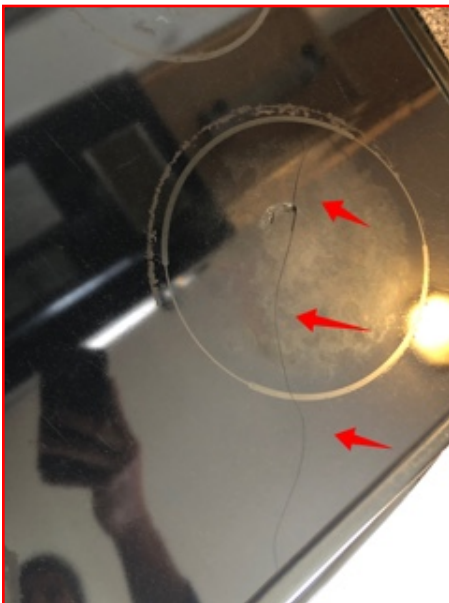
Figure 35-1

23) Cooktop crack at the top of range, replacement is recommended by a qualified appliance repair contractor.

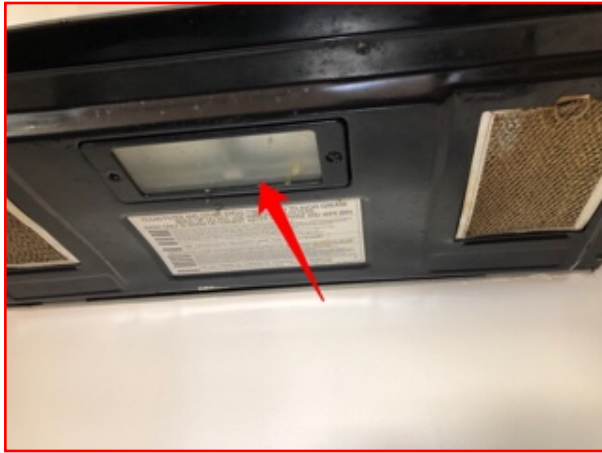
Figure 36-1

24) Lightbulb out at surface light, microwave. Replacement is recommended by a qualified handyman.

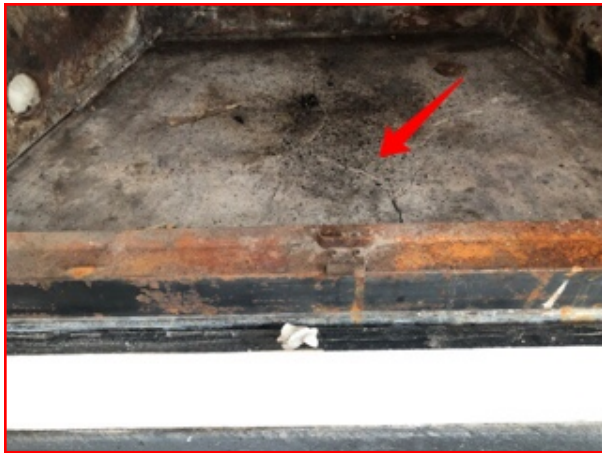
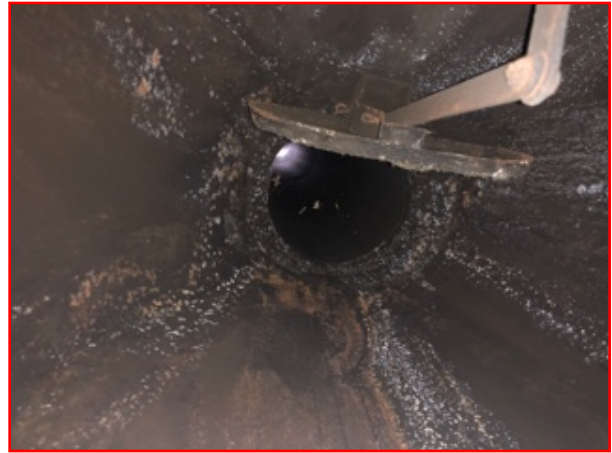
25) Cracks in floor of firebox, rusty frame around firebox. Further evaluation is recommended by a qualified chimney sweep contractor.

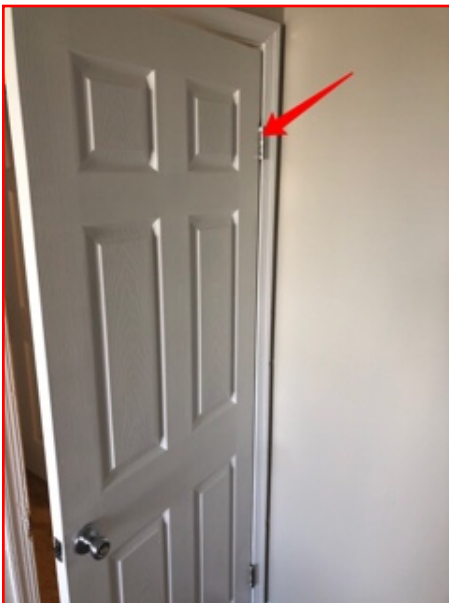
Figure 39-1

26) Hinge loose at top of door, repair is recommended by a qualified handyman.

Master bedroom door.

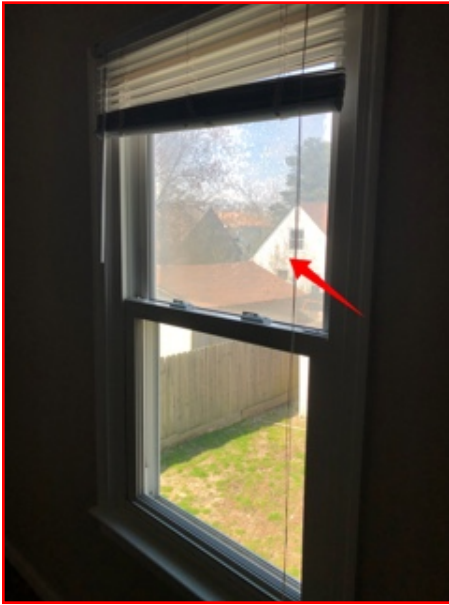
Figure 40-1

27) Damaged glass at bedroom window, window is fogged. Repair is recommended by a qualified window replacement contractor.
