Home Inspection Report

4118 Eastham Rd

Virginia Beach, VA 23453

Inspected on Mon, Mar 18 2019 at 10:46 AM

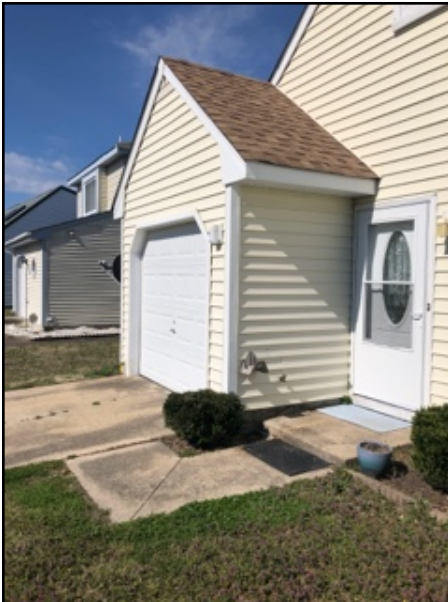
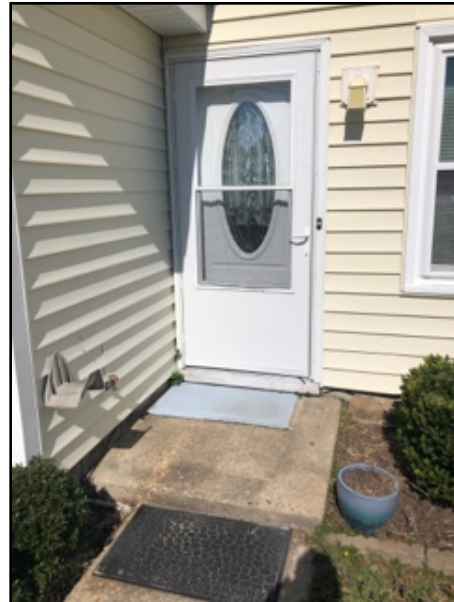
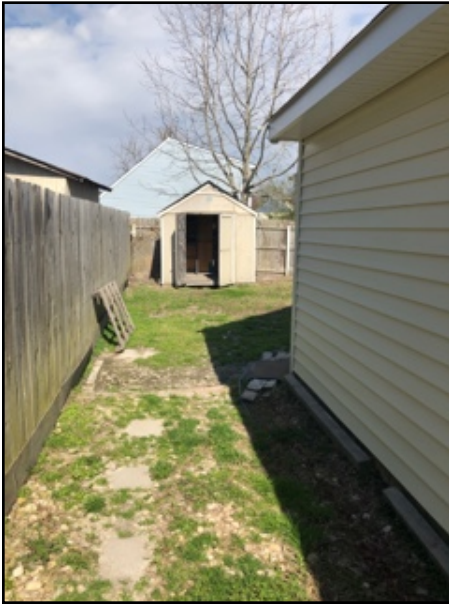
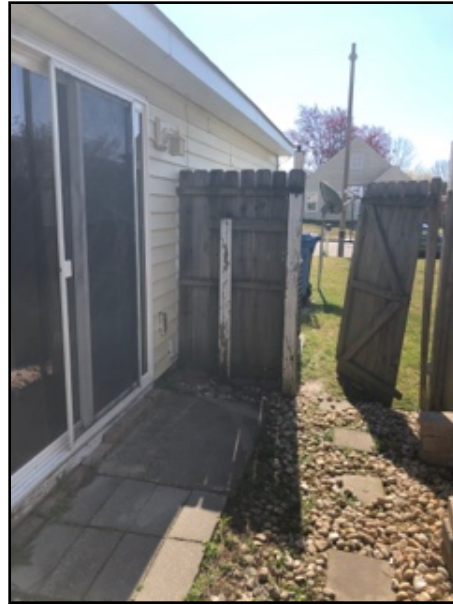
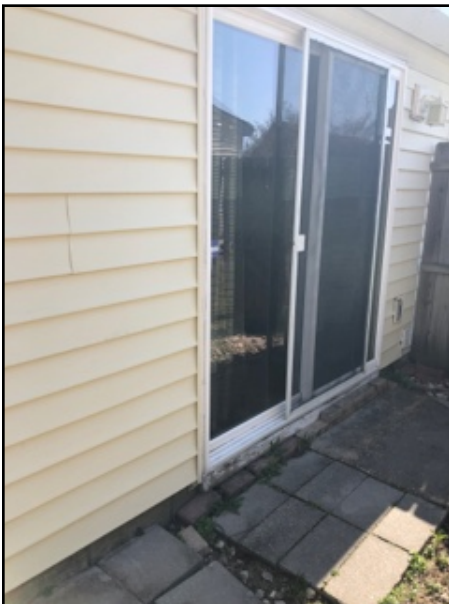
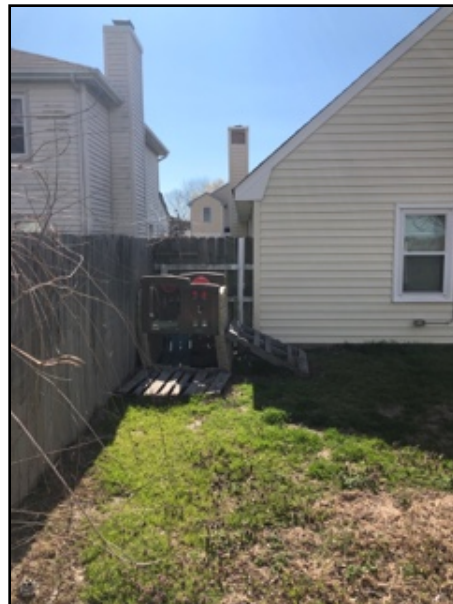
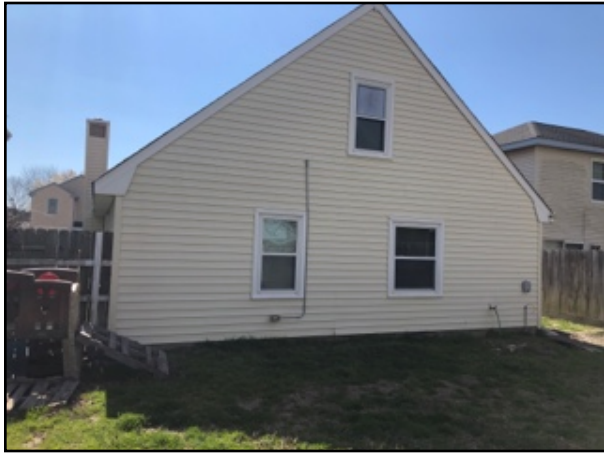
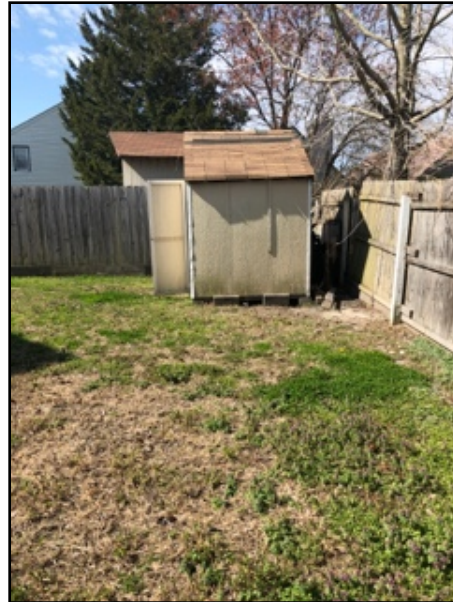
Comment 2:
Exterior pictures .

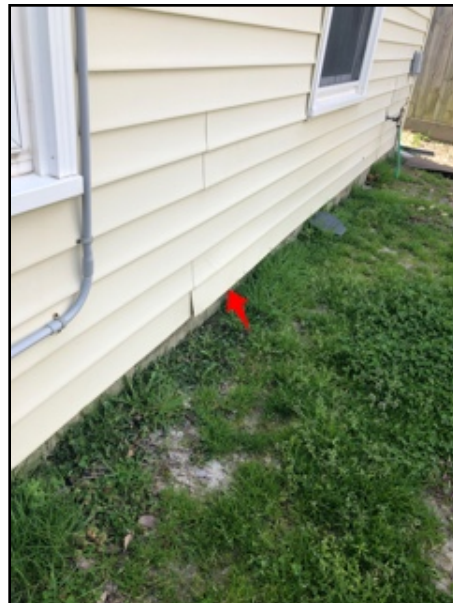
Figure 3-2

Loose vinyl siding, bottom row, front & back of house, repair is recommended by a qualified vinyl siding contractor.

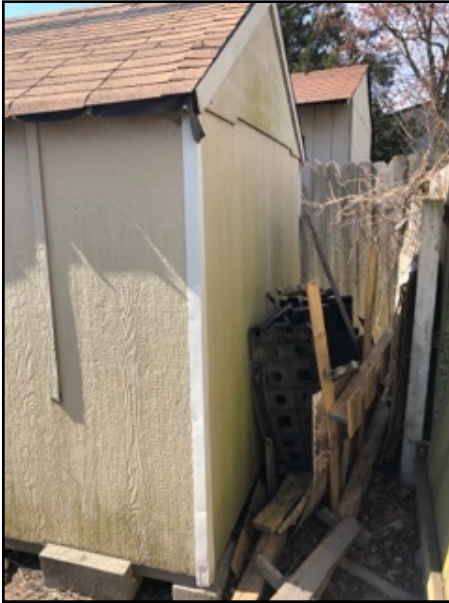
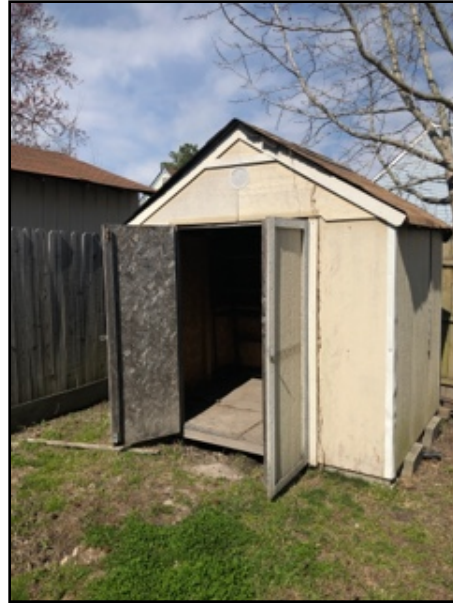
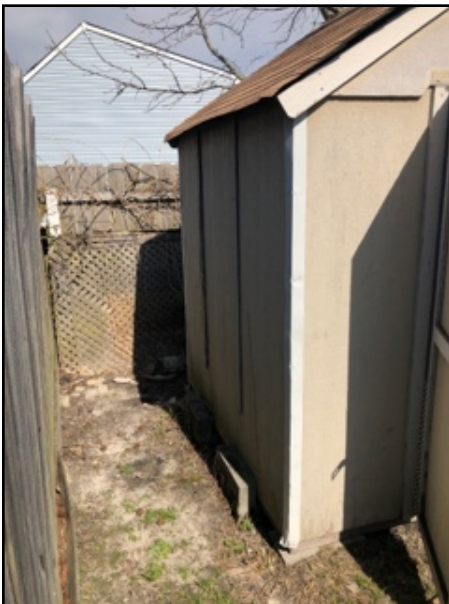
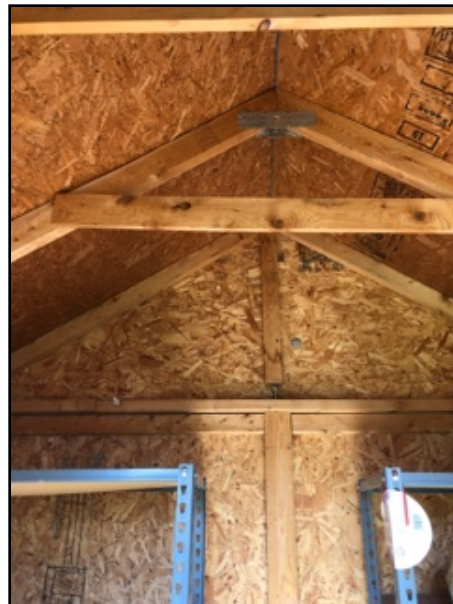
Comment 10:
Shed pictures.

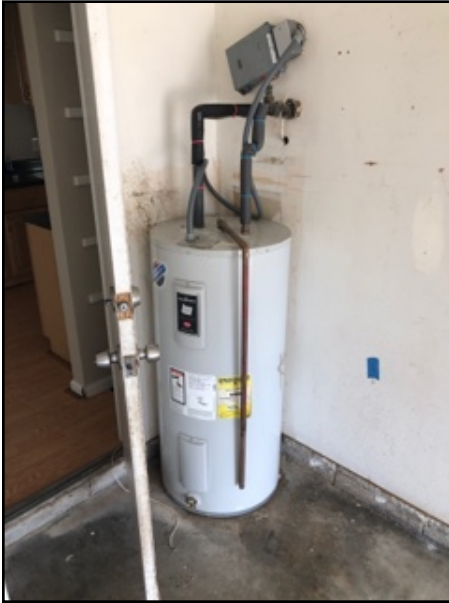
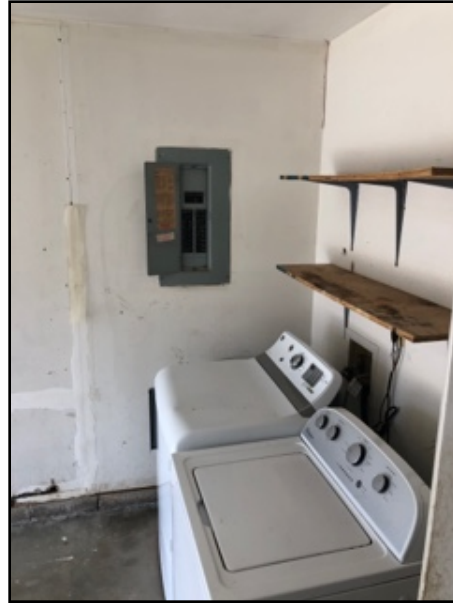
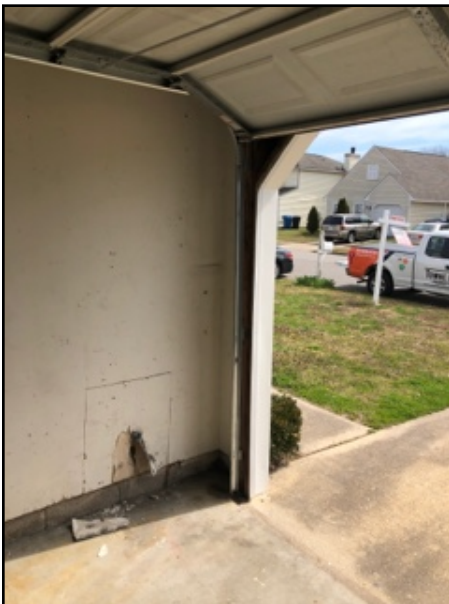
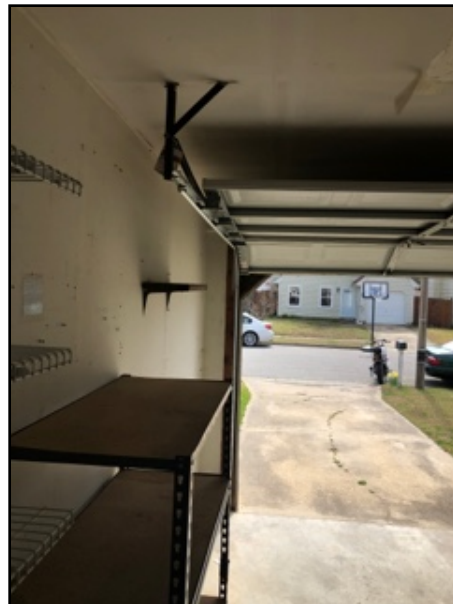
Comment 14:
Garage .

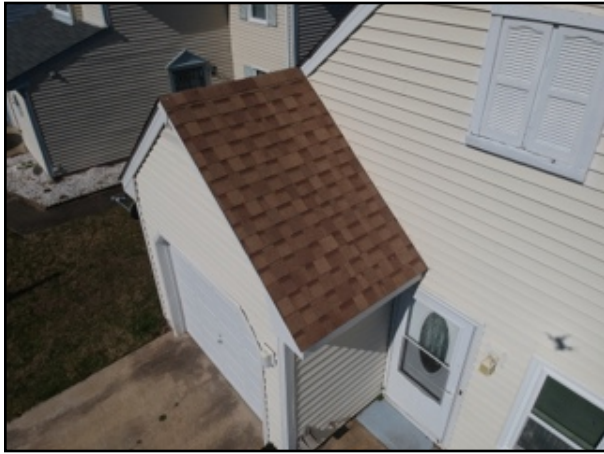
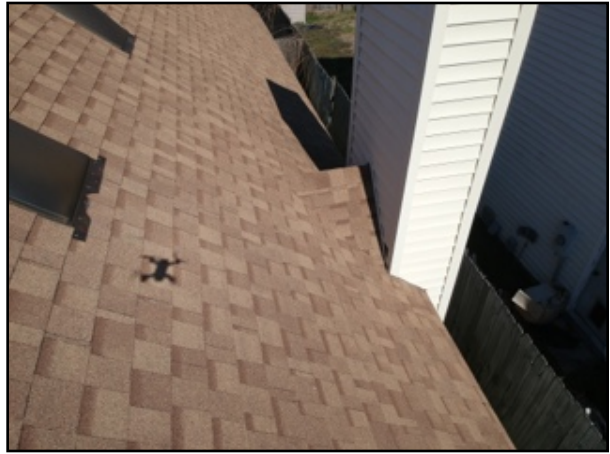
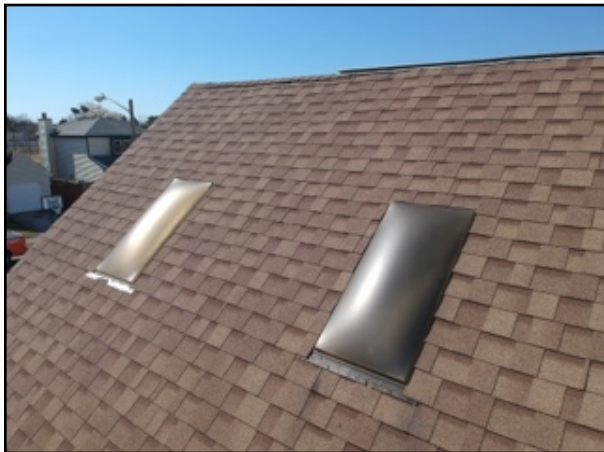
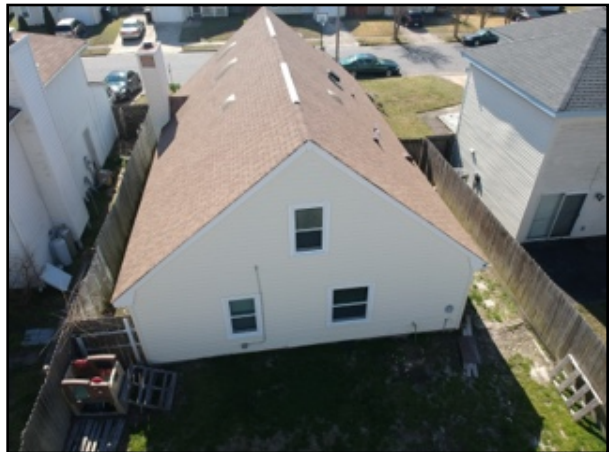
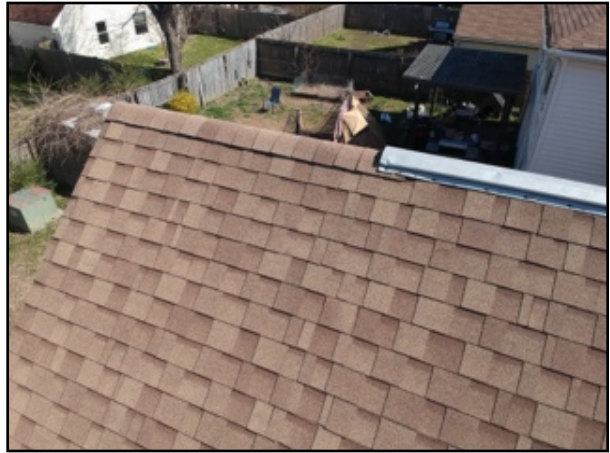
Comment 16:
Roofing pictures.

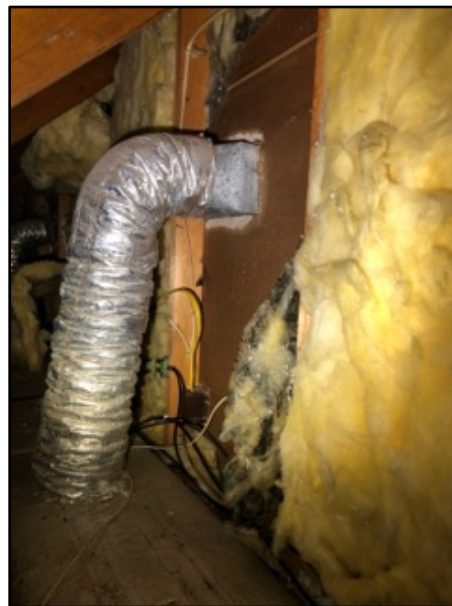
Figure 18-2

Missing insulation at interior walls facing attic. Replacement of missing insulation is recommended by a qualified insulation contractor.

Pest feces at attic. Pest treatment is recommended by a qualified termite and pest contractor.

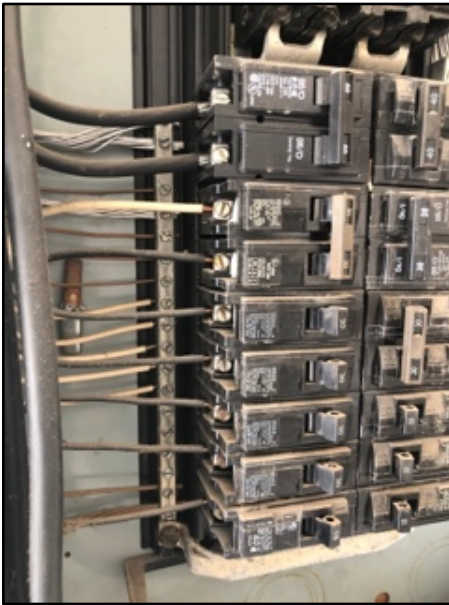
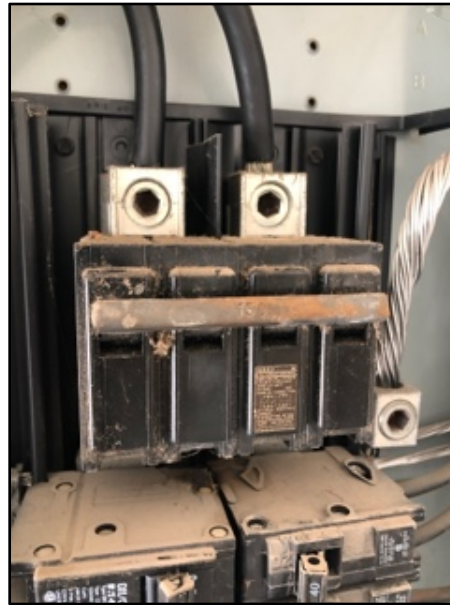
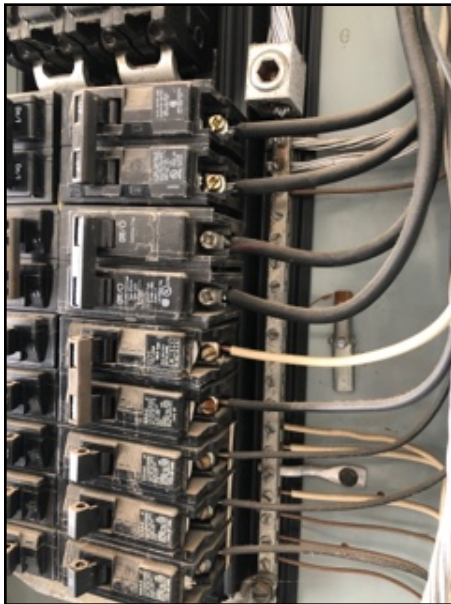
Comment 19:
Panel at garage .

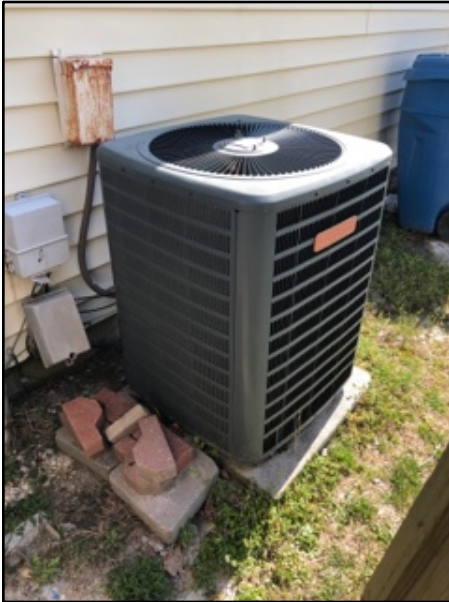
Figure 21-1

Heat pump manufactured in 2006. All equipment should be evaluated and cleaned by qualified HVAC technician.

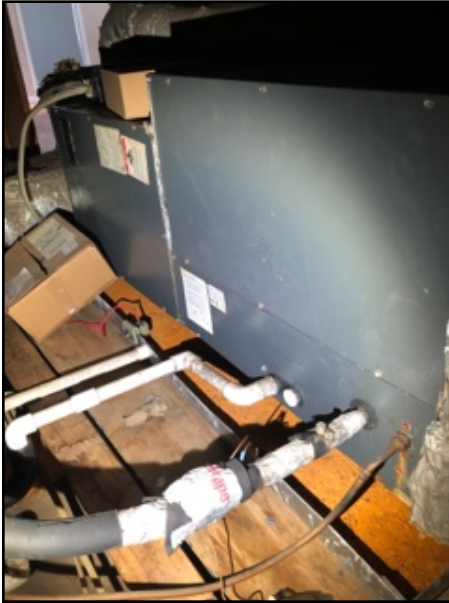
Figure 22-1

Heat pump and air handler manufactured in 2006.

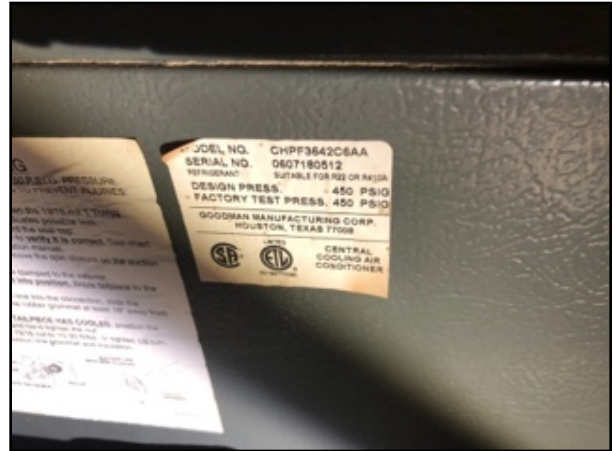
Figure 22-2

Return air duct loose at connection to cabinet, air coming in directly from attic. Correction and repair is recommended by a qualified HVAC contractor.

Check valve not connected at air handler in attic. Further evaluation is recommended by a qualified HVAC contractor.

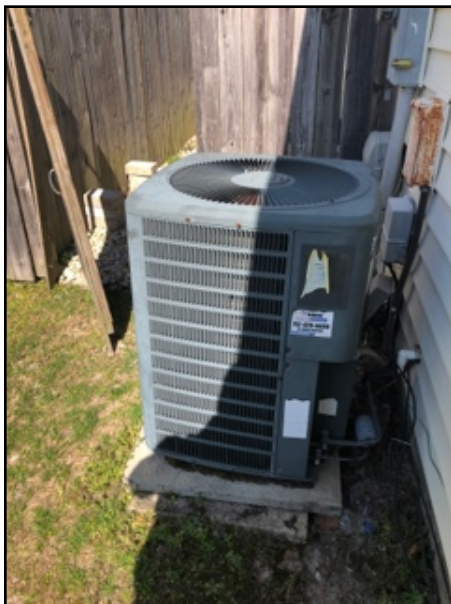
Figure 24-1

**Comment 24:**
Heat pump manufactured in 2006. All equipment over 10 years old should be serviced and evaluated by a qualified HVAC technician.

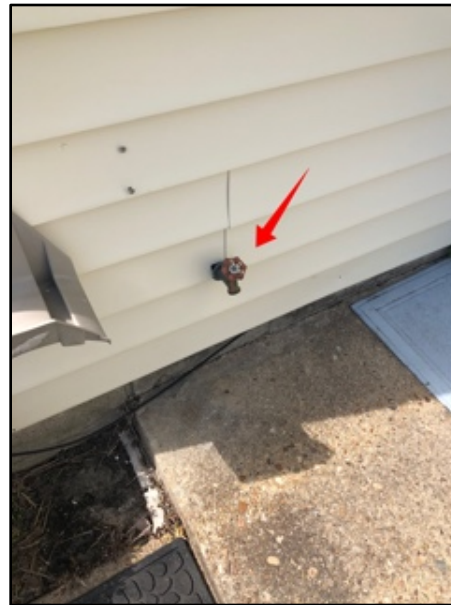
Figure 26-2

Spigot loose at front of house, repair is recommended by a qualified plumbing contractor.

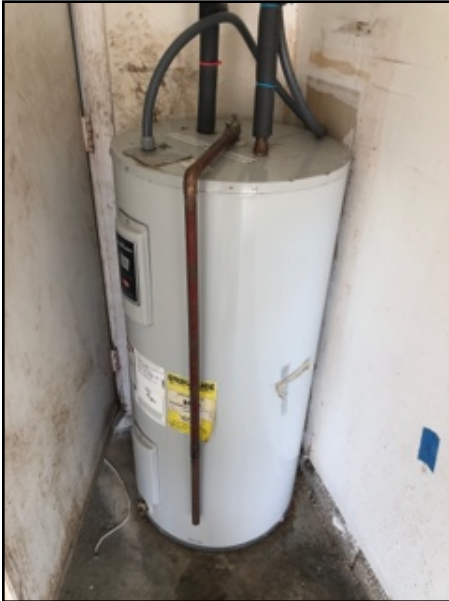
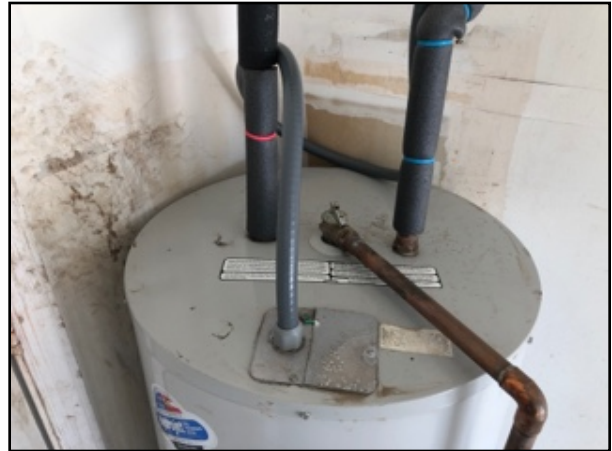
Water heater manufactured in 2009.

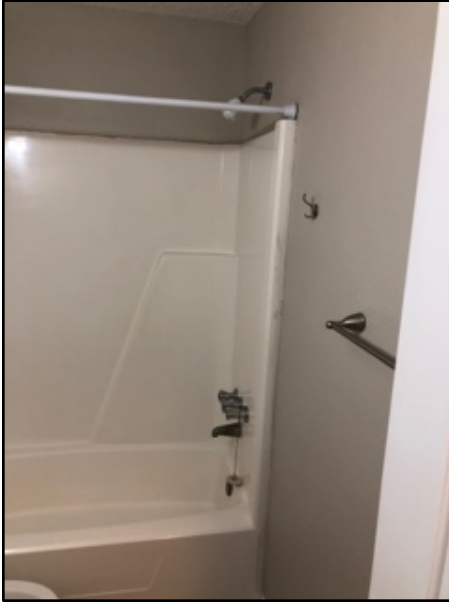
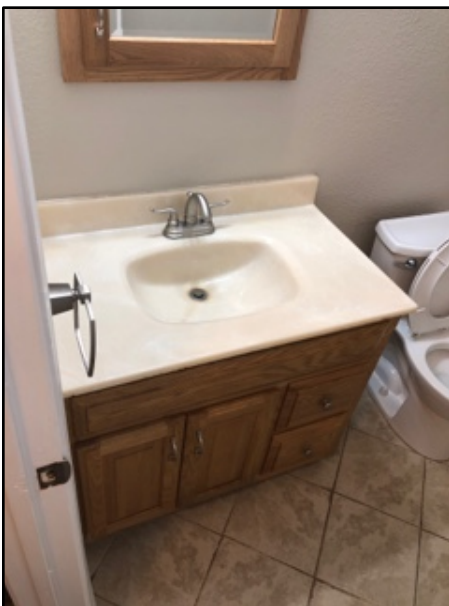
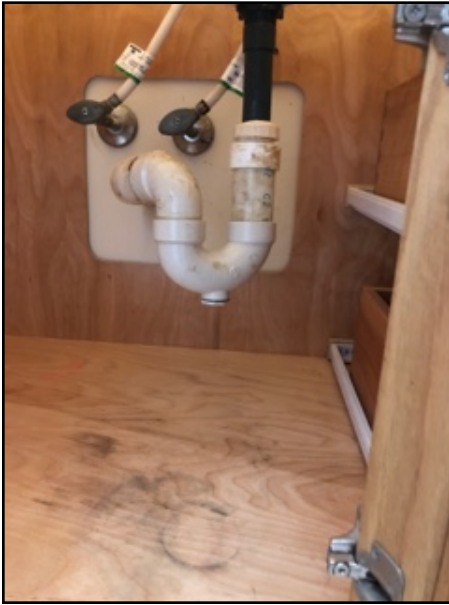
Comment 30:
Hallway bathroom.

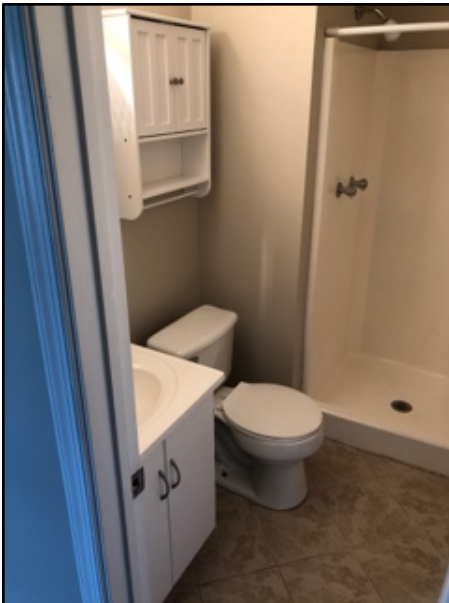
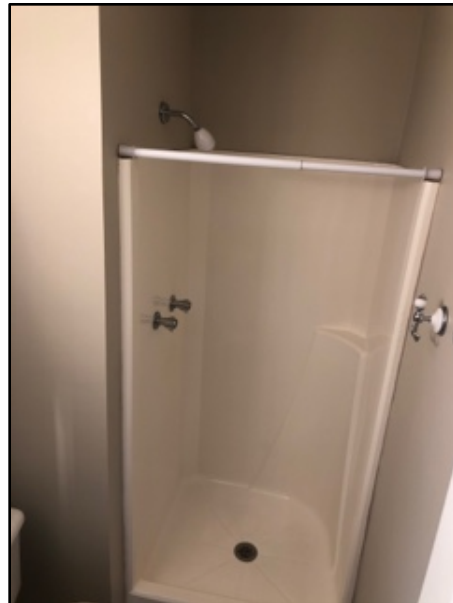
Comment 31:
Master bath.

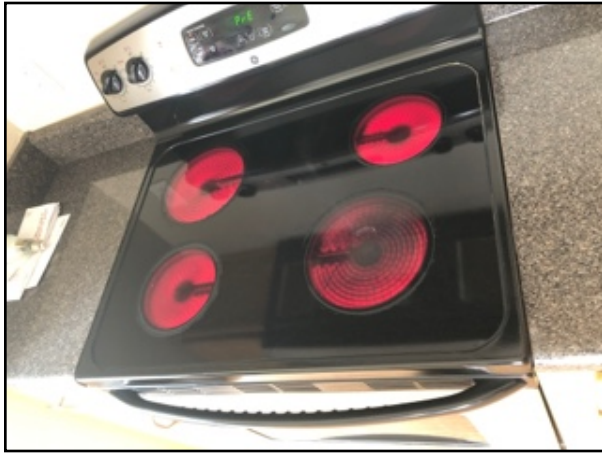
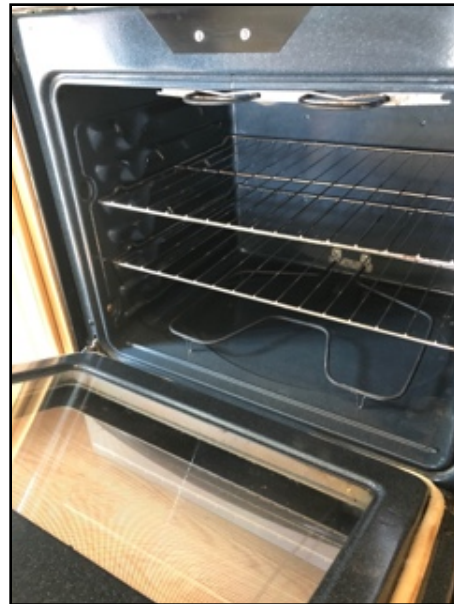
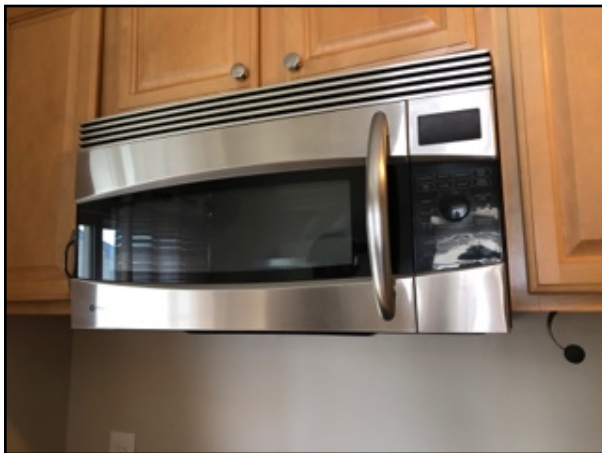
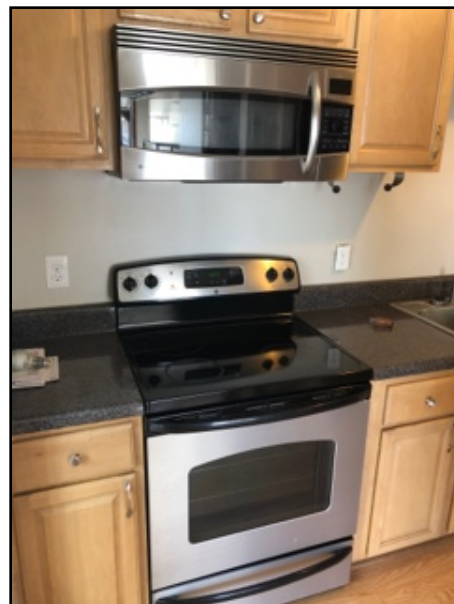
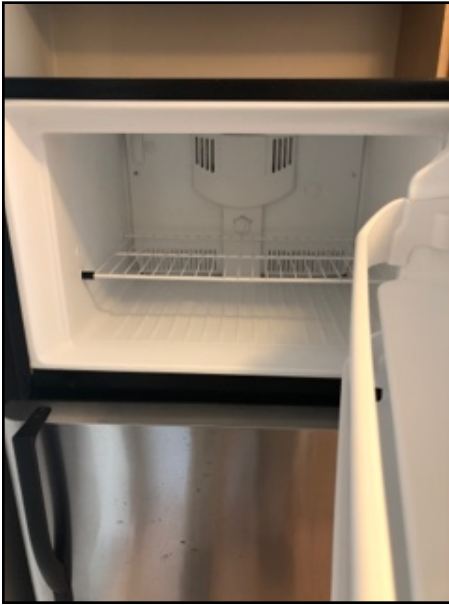
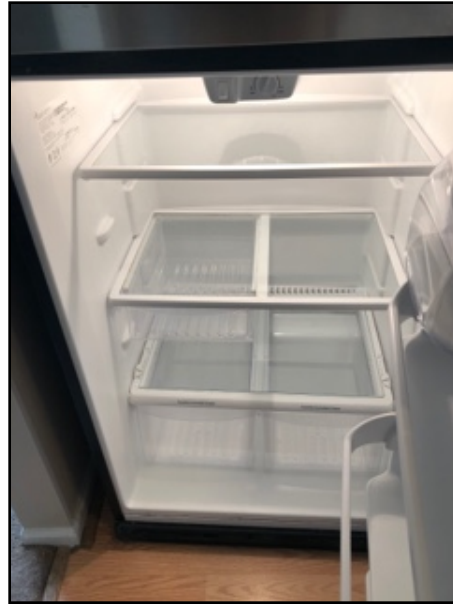
Comment 34:
Appliances .

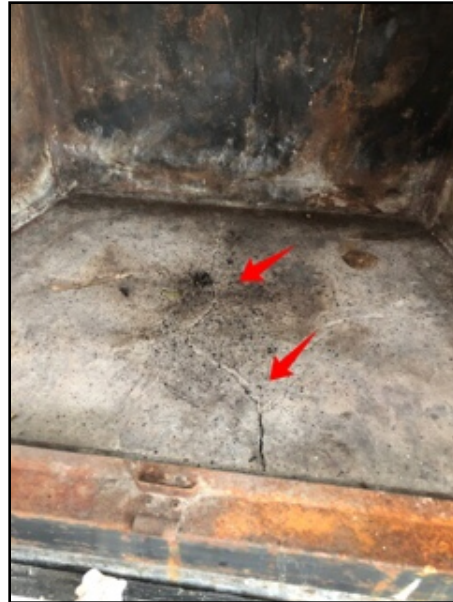
Figure 38-2

**Comment 38:**
Cracks in floor of firebox, rusty frame around firebox. Further evaluation is recommended by a qualified chimney sweep contractor.

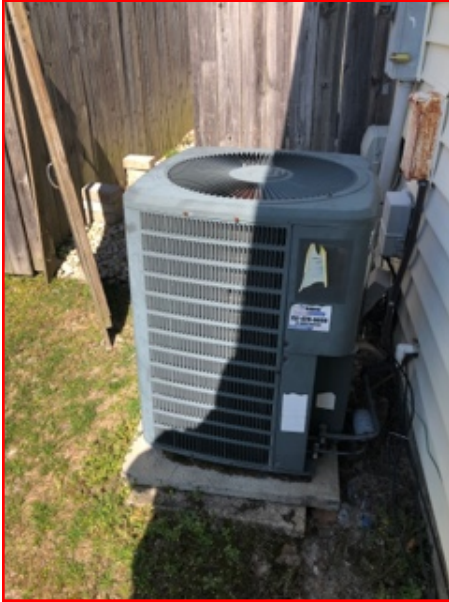
Figure 24-1

18) Heat pump manufactured in 2006. All equipment over 10 years old should be serviced and evaluated by a qualified HVAC technician.

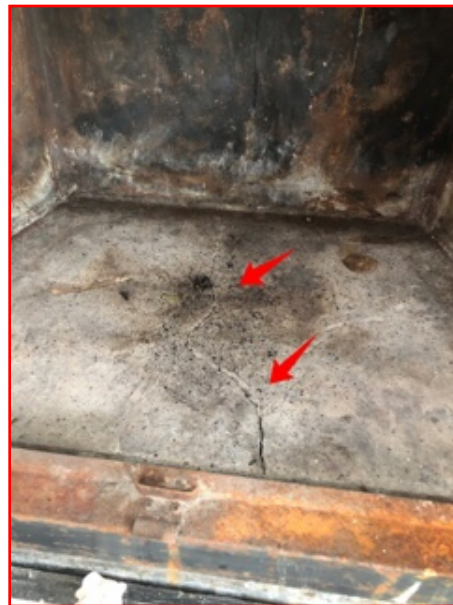
Figure 38-1

25) Cracks in floor of firebox, rusty frame around firebox. Further evaluation is recommended by a qualified chimney sweep contractor.
